Smoke and Dye-Water Observation Summary

Western Run Pilot Project - Baltimore Maryland

INSPECTION REPORT

STREET: PARKS HEIGHTS AVE. 94 B 1	MAP #1: 1	MH: 1521101
CITY: BALTIMORE	MAP #2:	MH: 1521102
LOCALE: MAIN RESIDENTIAL STREET	TAPE #: JAM 2	TV'D LGTH: 36.22 ft

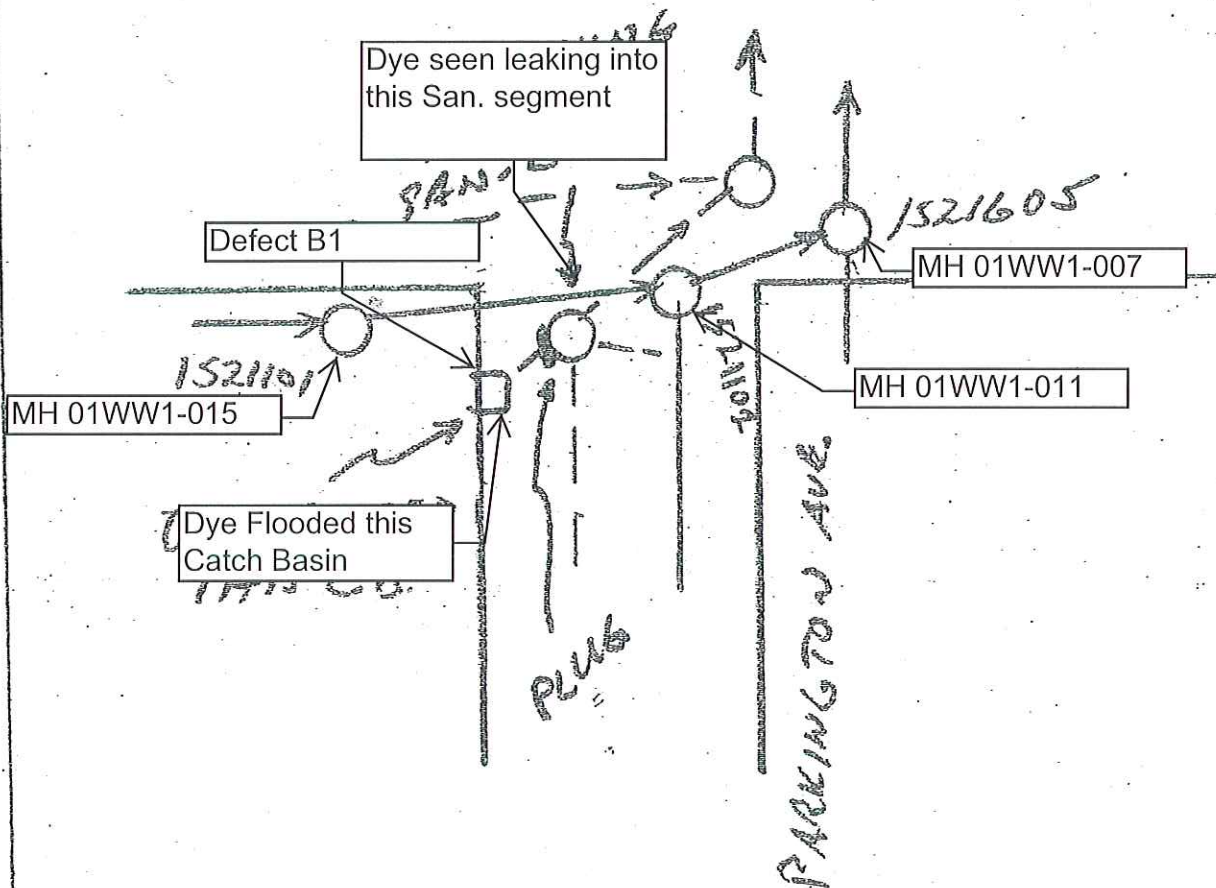
Dye Test 94

RESULT CODES		SOURCE TYPE CODES		
1. POSITIVE	1. MAIN SEWER	5. DOWN SPOUT	9. STAIRWELL DRAI	13. STORM DRAIN
2. NEGATIVE	2. SERVICE LINE	6. DWNSPT CONN.	10. FOUNDATION DRAIN	14. CATCH BASIN
3. CANNOT TEST	3. TRANSITION JOIN	7. AREA DRAIN	11. BUILDING INTERIOR	15. STORM MH
	4. CLEAN OUT	8. DRIVEWAY DRAIN	12. MH FRAME/SEAL	16. STORM DITCH
Additional Comments: DYE LEAKING INTO LINE BETWEEN				
1521101 & 1521102				
PHOTO DID NOT MATCH SKETCH

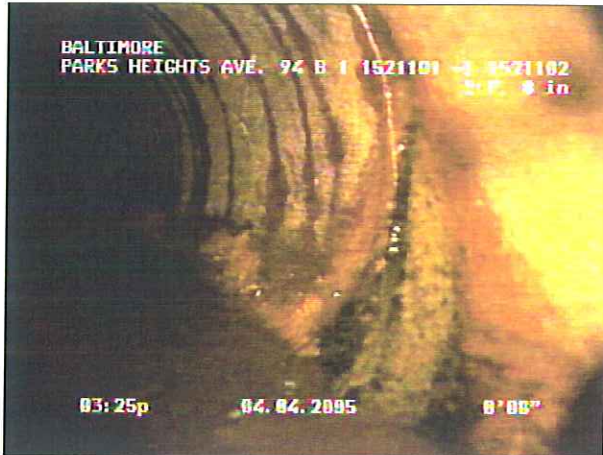
IMAGE: 2a, TAPE #: JAM 2, 00:01:07
3FT, Infiltration Running at joint at 03 o'clock

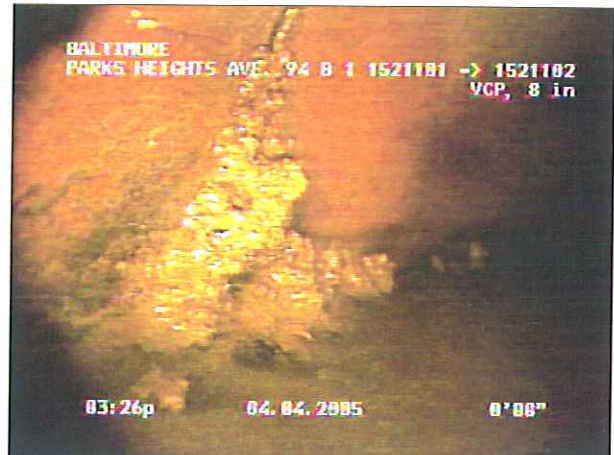
IMAGE: 3a, TAPE #: JAM 2, 00:01:47
6FT, Infiltration Running at joint at 07 o'clock

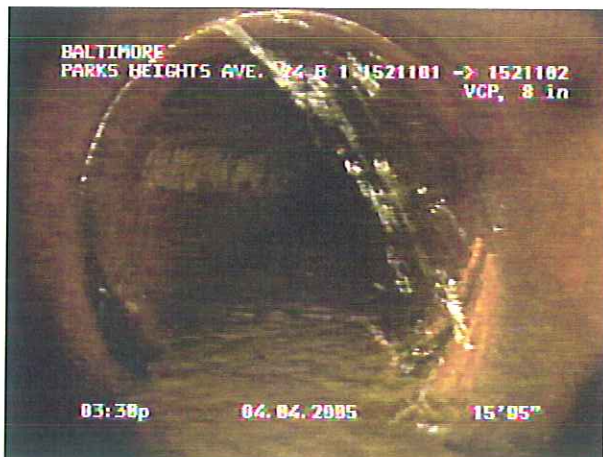
IMAGE: 4a, TAPE #: JAM 2, 00:03:42
15.39FT, Infiltration Gushing at joint at 12 o'clock

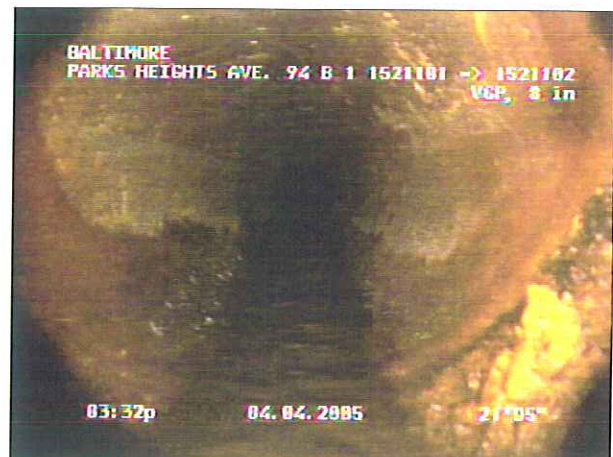
IMAGE: 5a, TAPE #: JAM 2, 00:04:44
21.43FT, scale/mineral deposits at joint from 03 to 09 o'clock medium, START

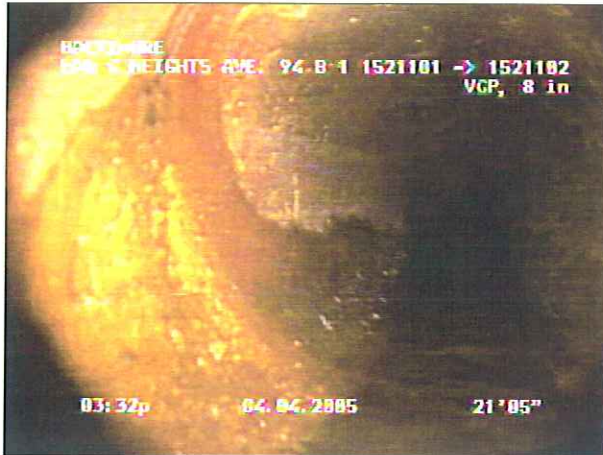
IMAGE: 5b, TAPE #: JAM 2, 00:04:44
21.43FT, scale/mineral deposits at joint from 03 to 09 o'clock
medium, START

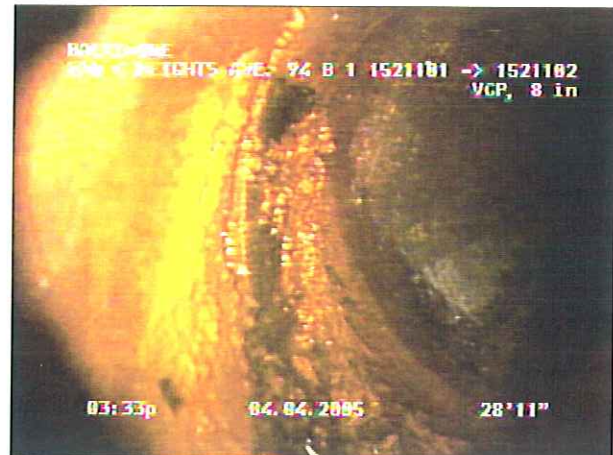
IMAGE: 7a, TAPE #: JAM 2, 00:04:53
28.88FT, Infiltration Seeping at joint at 09 o'clock

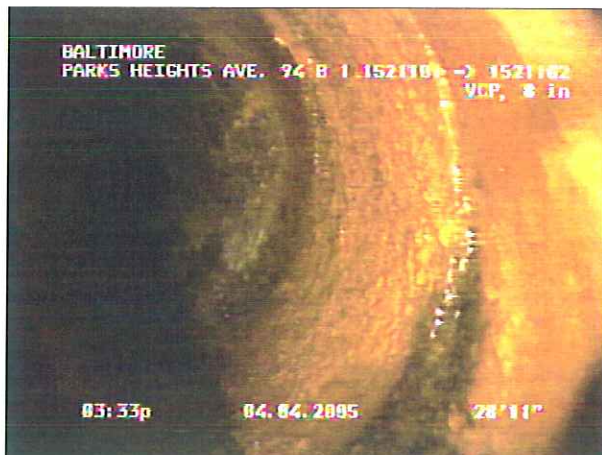
IMAGE: 6a, TAPE #: JAM 2, 00:04:53
28.88FT, Infiltration Running at joint at 03 o'clock

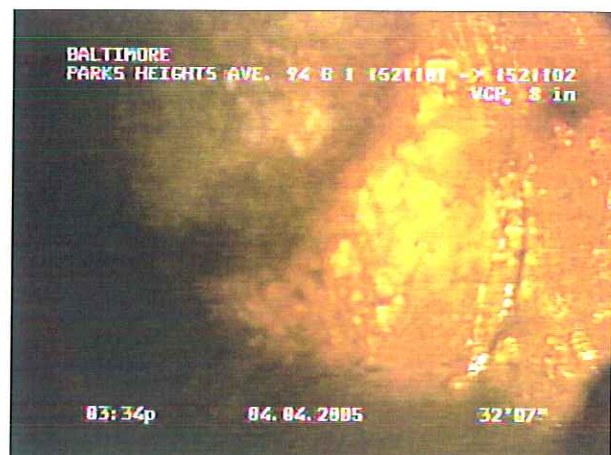
IMAGE: 8a, TAPE #: JAM 2, 00:05:29
32.6FT, Infiltration Seeping at joint at 04 o'clock

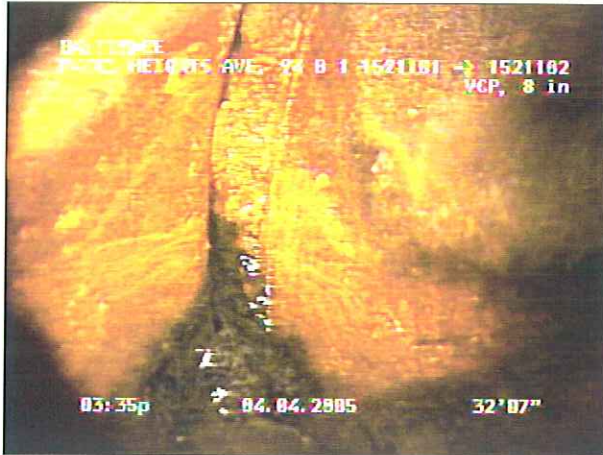
IMAGE: 9a, TAPE #: JAM 2, 00:05:29
32.6FT, Infiltration Seeping at joint at 08 o'clock
